## REPAIR OF THREADED SPINDLE ON FRICTION SCREW PRESSE FZP-160

**Abstract:** The threaded spindle of the friction screw press is an important structural element that has a function of achieving an operating stroke for deformation and a return stroke and to receive all the strain that appear while working. During this operation of the threaded spindle, its vibrations appear which are undesirable. In accordance with the load of the threaded spindle and the source of vibration, the lower unthreaded part of the threaded spindle is a critical local spot where the appearance of initial cracks is possible. These cracks allow that the operating tensions at the sepceific spots of the cracks overcome critical tensions, which leads to the fracture of the spindle during exploitation. In accordance with this problem, in this paper the engineering approach has been presented of the performed reparation of the threaded spindle of the FPZ-160 friction srew press in practice.

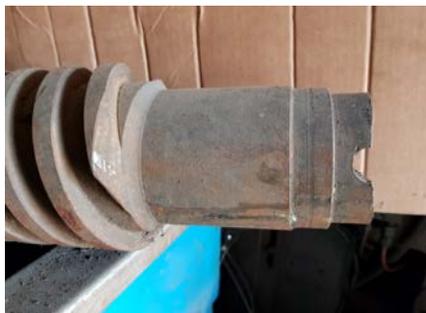
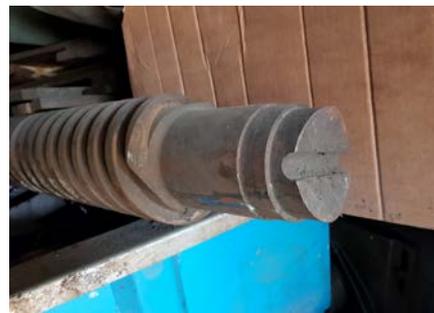
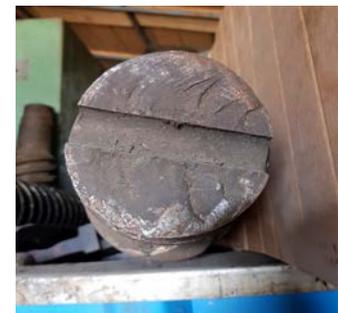
Picture 2. – Faults (cracks, deformations and breaks) on the threaded spindle

(piston) with the slick part of the threaded spindle remained in the lower end position, while the second part of the threaded spindle with the flywheel made a return stroke in the upper end position. In accordance with the previously defined problem, the following subchapters provide an engineering approach to the realized reparation of the threaded spindle of the friction screw press type FPZ-160 of the nominal workforce of 1600 kN.

After the failure in the exploitation of the threaded spindle of the friction screw press FPZ-160, an analysis of its condition was carried out. References [5, 6] were used as the basis. As the first step, in order to determine the condition of the damaged threaded spindle of the FZP-160 friction screw press, a preliminary visual inspection was carried out. As the second step, the condition of the threaded spindle was tested. The preliminary visual inspection of the condition of the damaged spindle of the press pointed to the presence of serious faults (discontinuity) of the type of cracks, fractures and deformations on the surface of the threaded spindle. The concentration of these errors was at the lower end of the threaded spindle which is associated with the pressure gauge (piston). Some of the mentioned errors are shown in Picture 2 (a - c).

Based on the results of testing the damaged threaded spindle, on the one hand, and analysis of the economic aspect, on the other hand, it was decided to repair the observed faults (cracks, deformations and breaks) on the threaded spindle.

Taking into account how serious the damage to the threaded spindle end (which is attached to press piston) is, the conceptual solution for the reparation of the damaged threaded spindle is to do reparation of the threaded spindle. Reparation is a precisely defined sequence of operations that should be consistently implemented in order to restore lost operational ability to worn and / or broken machine parts.

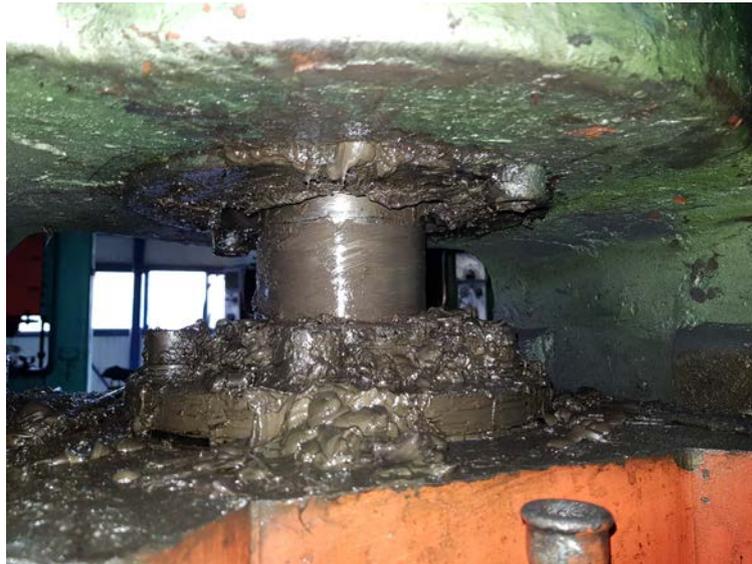
*Picture 4. – Repair of threaded spindle in exploitation*

After completing of all inspections of the repaired threaded spindle, the FPZ-160 friction screw press was installed, which included the installation of the repaired threaded spindle. Afterwards, trial tests were carried out on the operational force of the press, which confirmed that the repair of the threaded spindle was successfully performed. After this press was put back into exploitation (Picture 4).
